OUR VISION

**To create a
world powered
by renewable
energy**

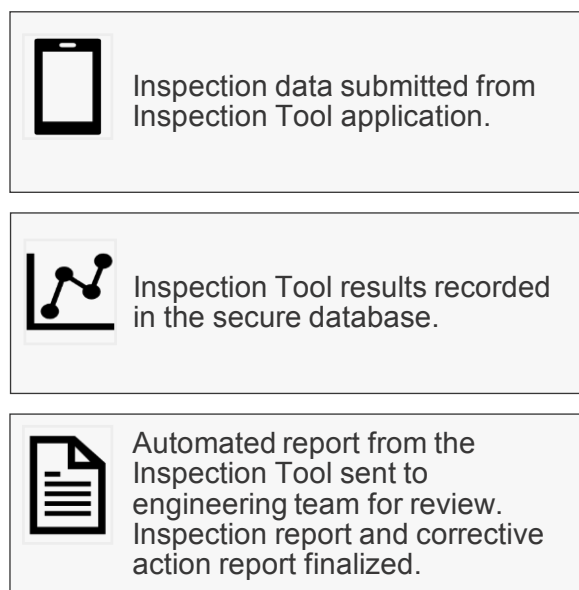
Figure 4.1: Summary of Inspection Tool

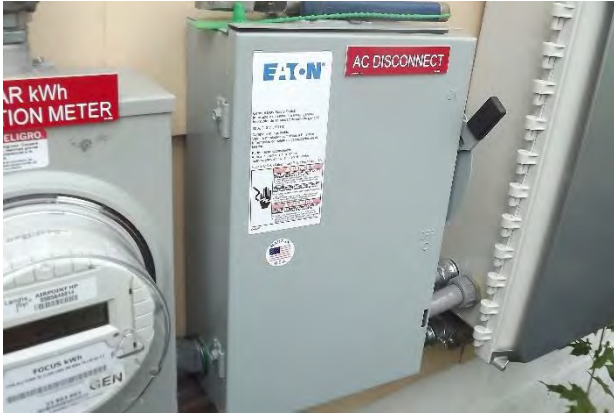
<p>The PV system disconnect is missing the following labeling/directories:</p> <ul style="list-style-type: none"> • Directory of power sources at the house (NEC 705.10). <ul style="list-style-type: none"> ◦ Showing how to safely de-energy all power to house. • PV system disconnect identification label (NEC 690.13(B)). • Rapid shutdown switch label (NEC 690.56(C)(2)). <ul style="list-style-type: none"> ◦ Notifying firefighters this switch will initiate rapid shutdown. • Rapid shutdown directory (NEC 690.56(C)). <ul style="list-style-type: none"> ◦ Identifying the type of rapid shutdown this array is equipped with.

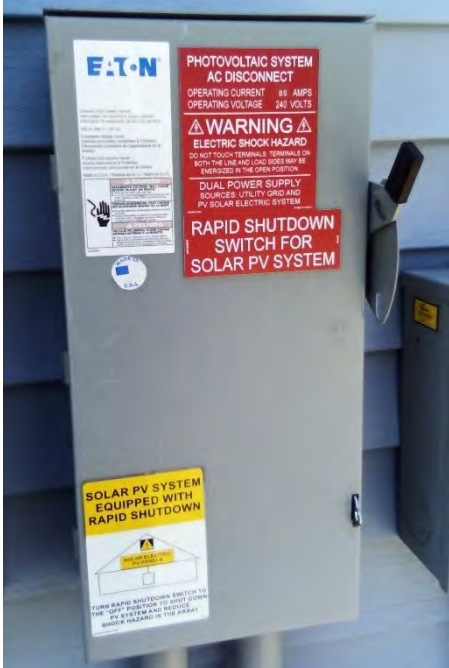
<p>Example of PV system disconnect with proper rapid shutdown and identification labeling. (Missing directory of power sources.)</p>

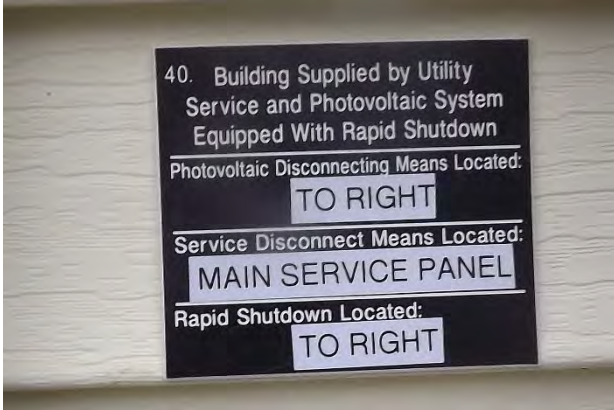
<p>Example of directory of power sources.</p>

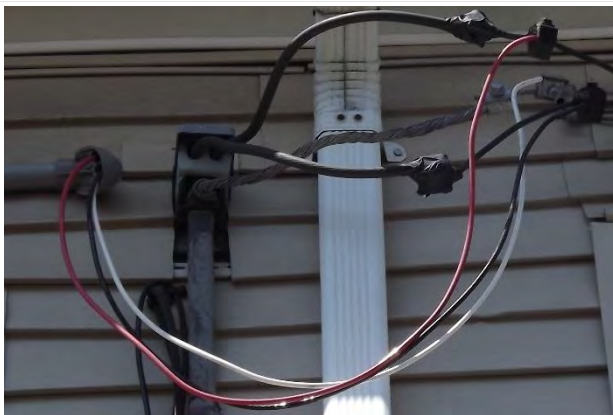
Non-UV rated conductors used for new PV service. (NEC 110.3(B) and 310.10(D))

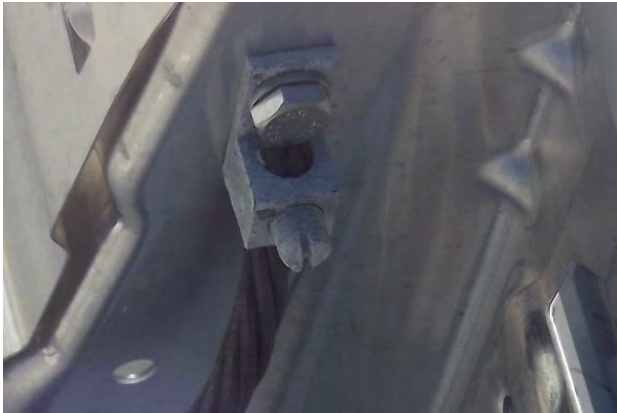
<p>Array grounding hardware corroded and not suitable for the environment. (NEC 110.3(B) and 690.43)</p>

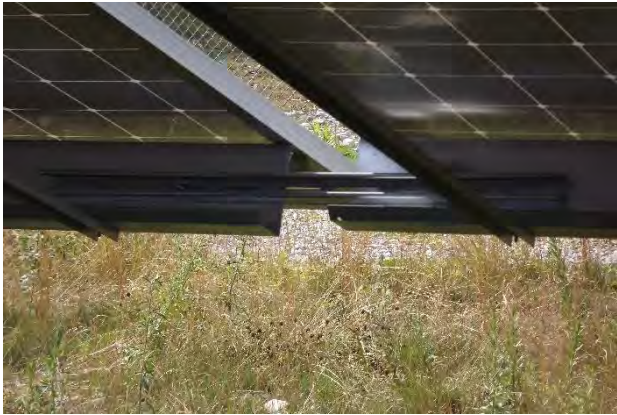
<p>Modules and racking not properly grounded due to improper/unlisted bonding means between rows. (NEC 690.43)</p>

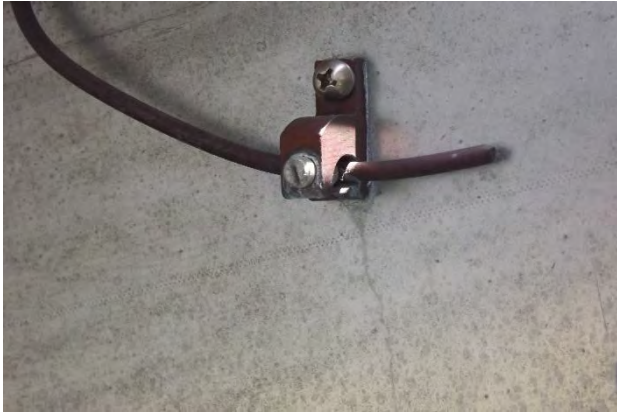
<p>Galvanic reaction between copper ground lug and steel racking. (NEC 110.14)</p>

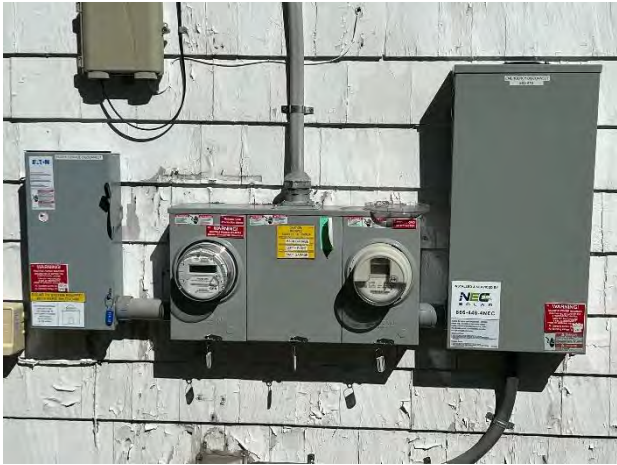
<p>Example of proper directory labeling indicating the presence and location of all sources at the service equipment, as required by NEC 690.56(B), 705.10, and 706.21. This was missing on 3 of the 4 inspections.</p>

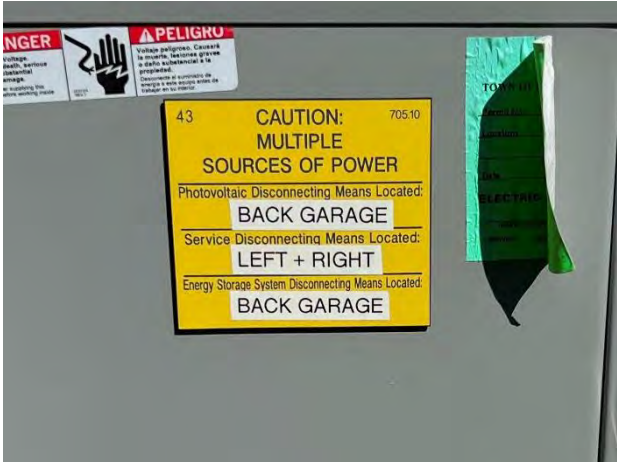
² <https://ngus.force.com/RI/s/article/RI-Interconnection-Documents>

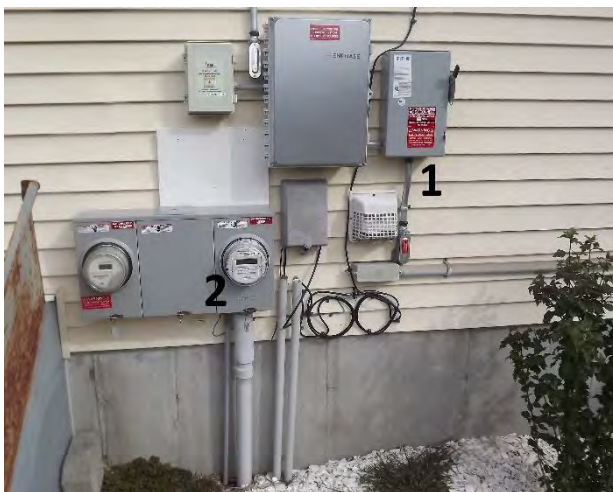
1. PV AC combiner output connected to the appropriate terminals in the system controller.
2. Wiring directly from REG meter to the system controller, missing the automatic transfer switch required by National Grid.
3. Battery wiring and termination.
4. Backup loads panel wiring and connection inside the system controller.

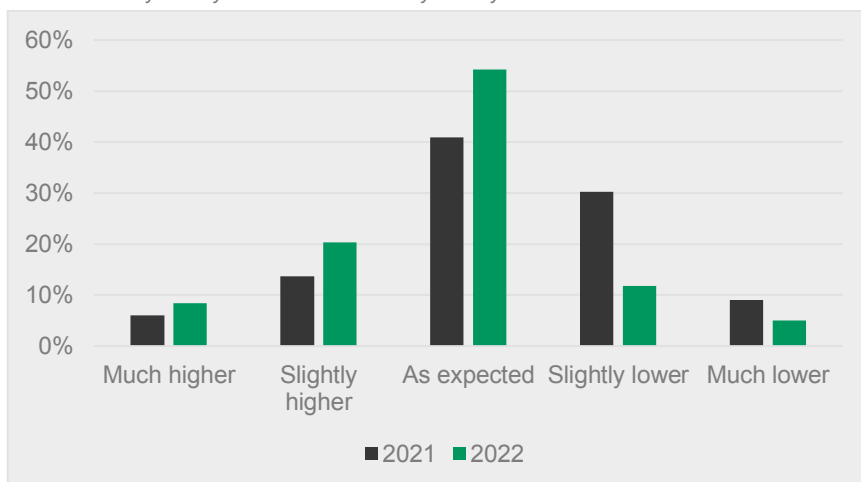
Figure 5.6: System Production Satisfaction
